# Using Acoustic Inspection to Prioritize Sewer Cleaning

**Bob Hunn, Jr.**

**Duke's Root Control, Inc.**

**10/12/18**

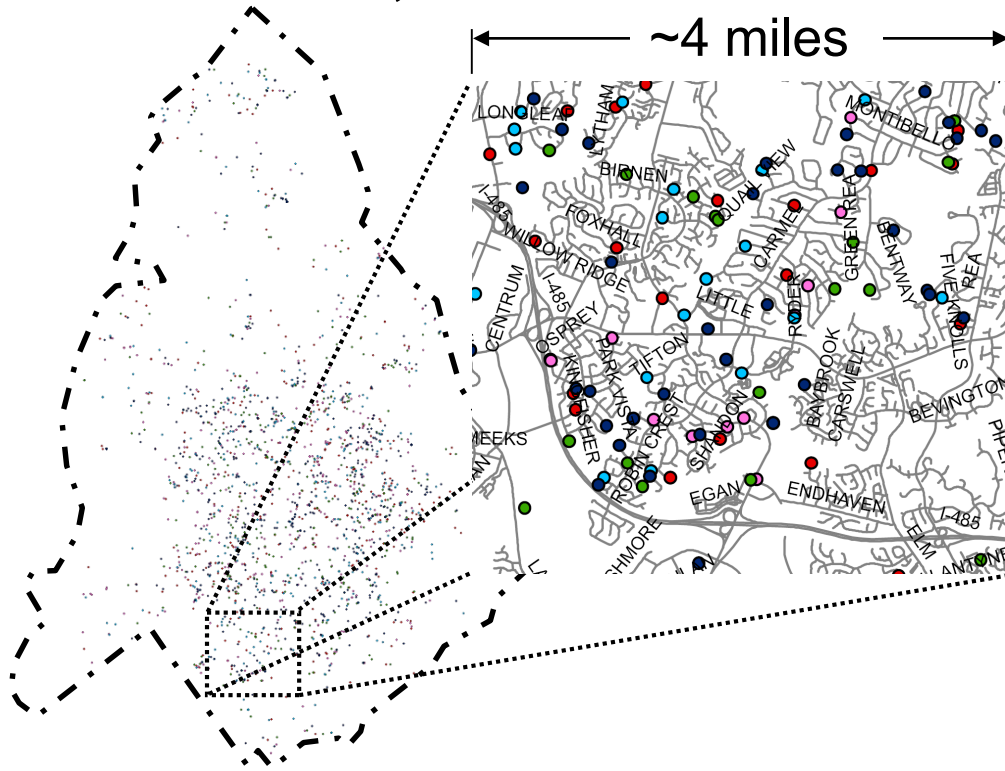
### Charlotte, North Carolina

### Five Year Overflow Record – Different Color / Year

- Overflow locations – “Random”
- >90% in pipes less than 12”
- Historical GIS – Helpful – But Insufficient
- Where & When to Deploy Cleaning Resources
- Cost Effective & Timely Condition Information

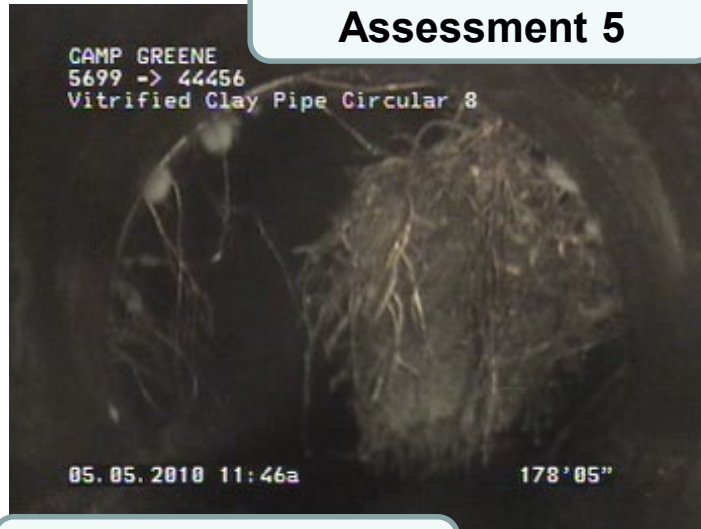
**Blockage Assessment 5**

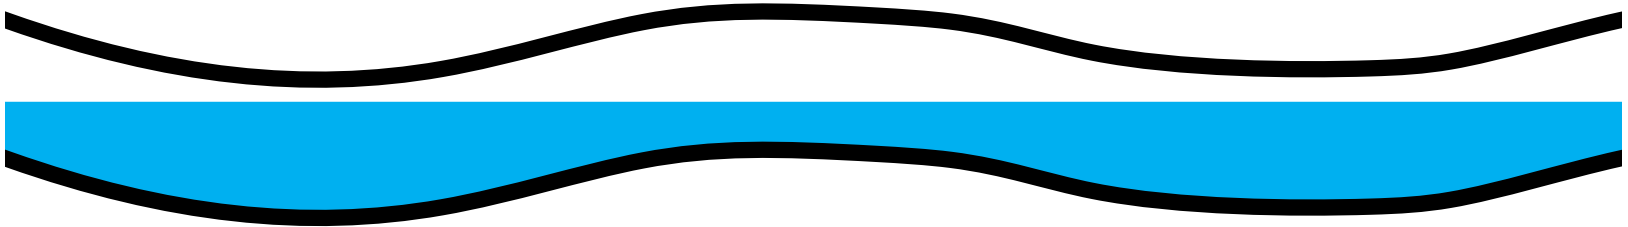
## Partial Pipe Sags

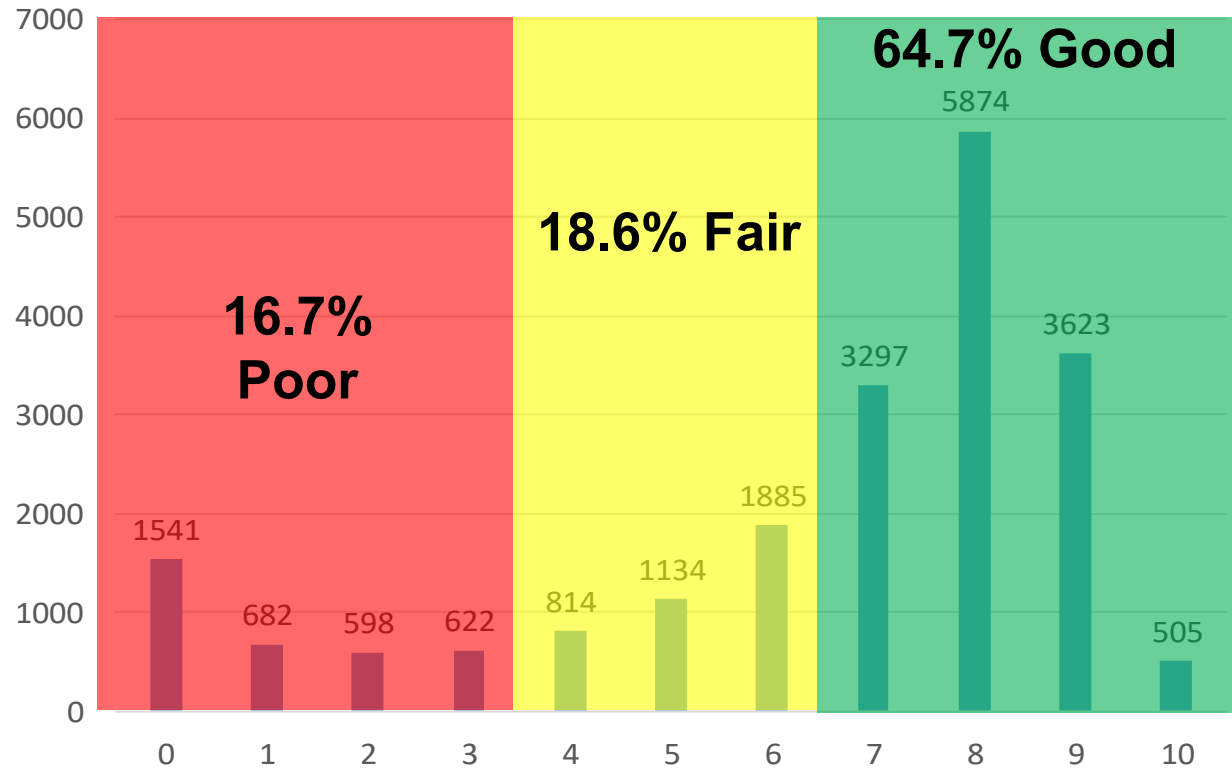
Histogram of Acoustic Scores

- >20,500 segments inspected in first ~30 months of work
- >20,000 manholes located and inspected
- >4.5 MILLION Feet (850 miles)

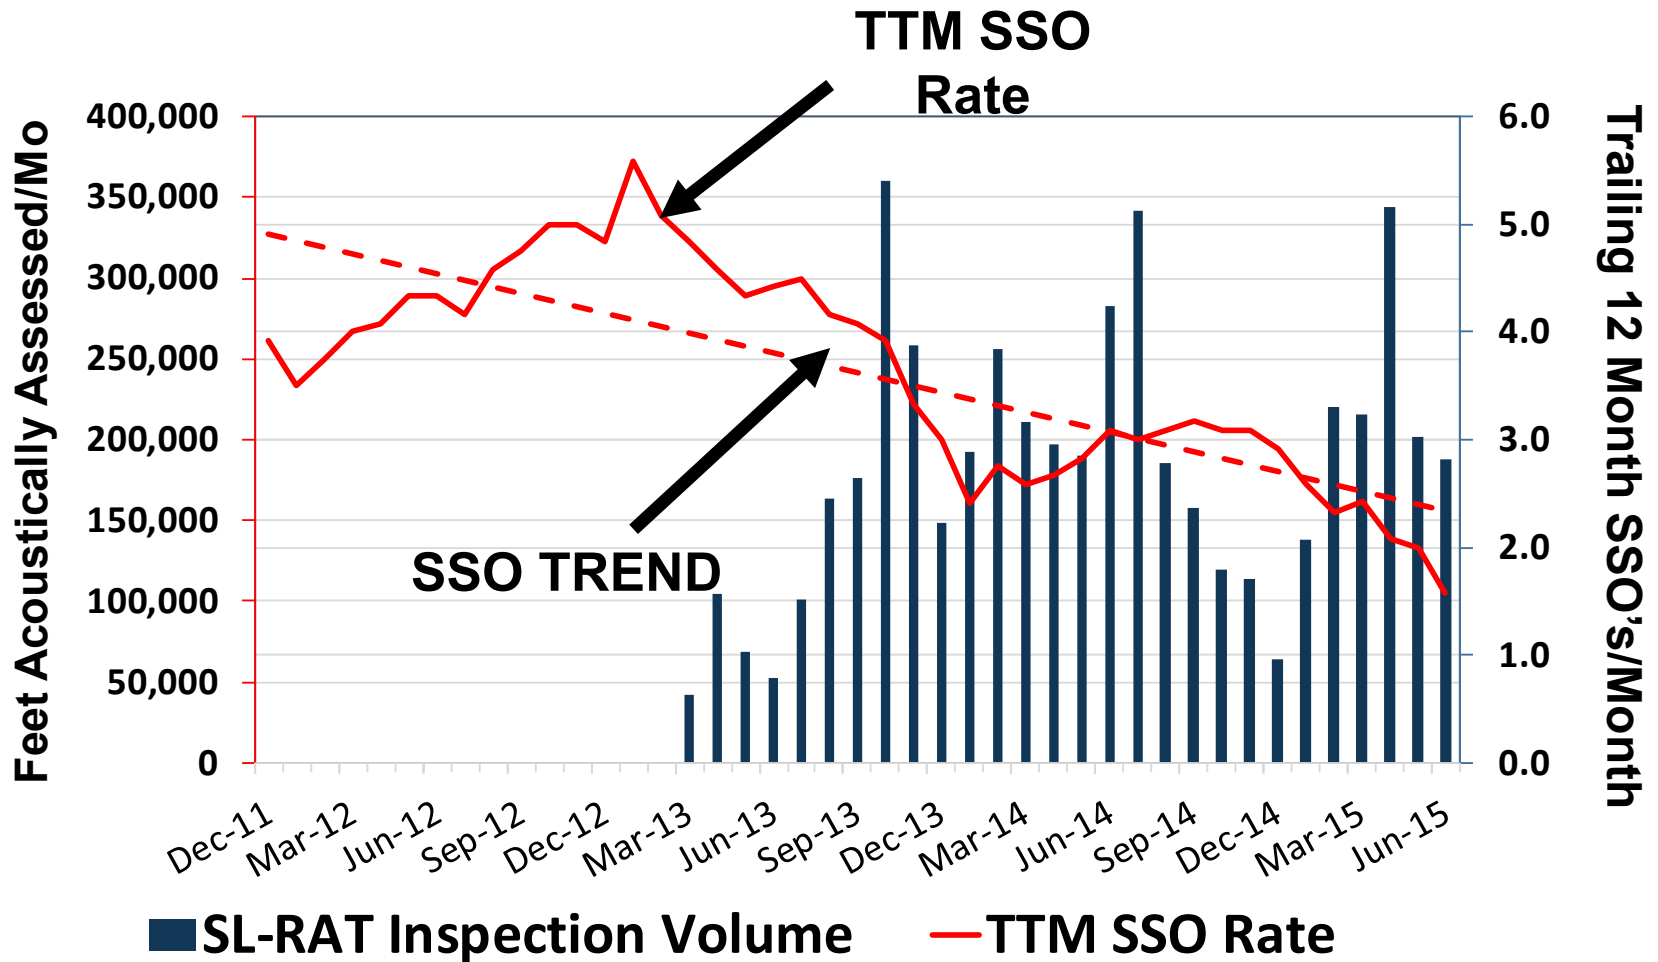
# SSO Rate Went Down >50% Since 2011

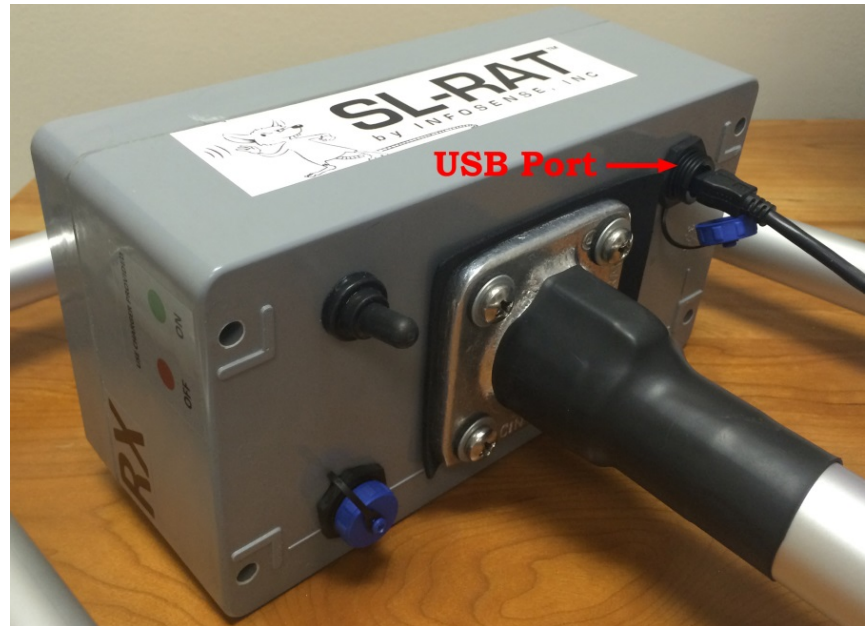
- **Step 1. Make sure data is synchronized between RX and TX devices**

This can be done manually from the menus on the devices, or by turning both units off and on again.

- **Step 2. Connect SL-RAT (RX) to a PC using the USB connection**
